SUBJECT: Final Point Arena AFS Second Five Year Review

**SECOND FIVE-YEAR REVIEW
FORMER POINT ARENA AIR FORCE STATION
POINT ARENA, CA**

SECOND FIVE-YEAR REVIEW REPORT
(AUGUST 2019 - AUGUST 2024)
FOR
FORMER POINT ARENA AIR FORCE
STATION, CALIFORNIA

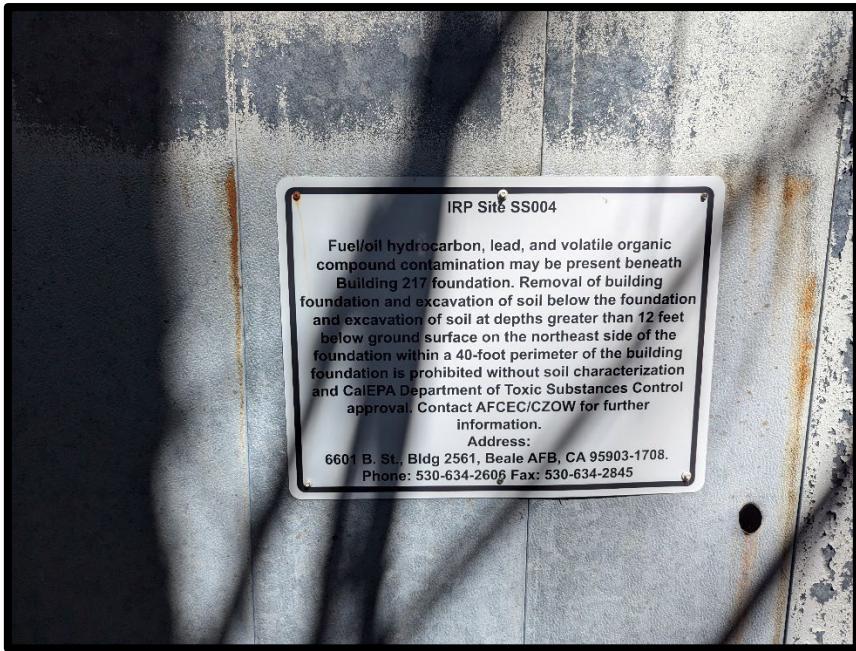
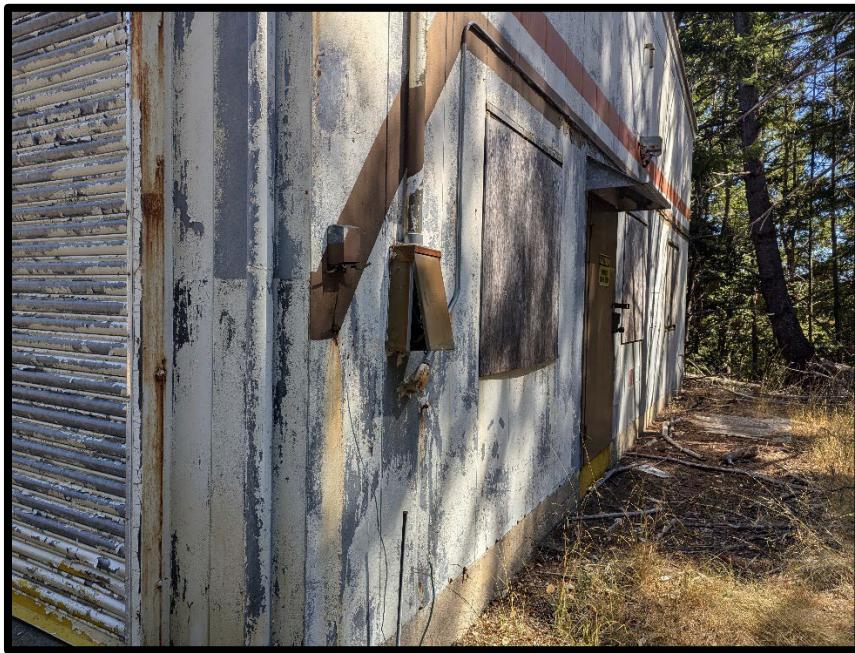
View of signage on southeast end of SS004, Building 217, former motor pool vehicle maintenance facility. No excavation of soil evident near building foundation. Building foundation intact and undisturbed.

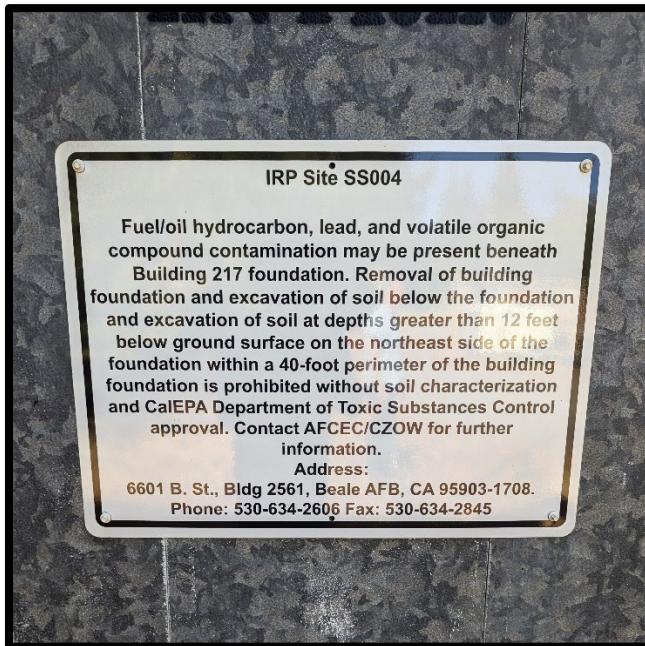
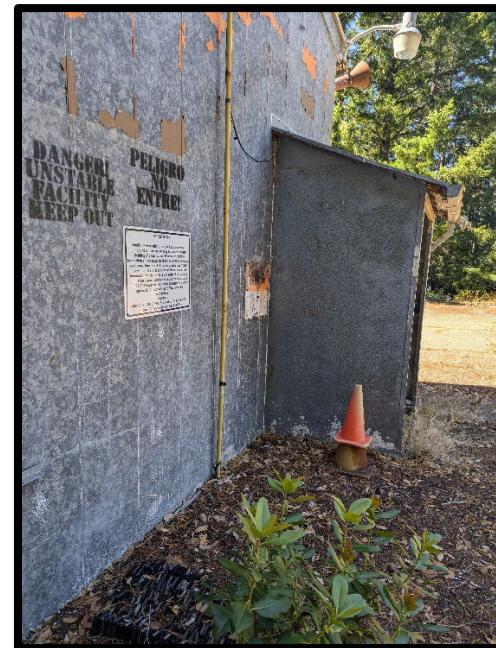
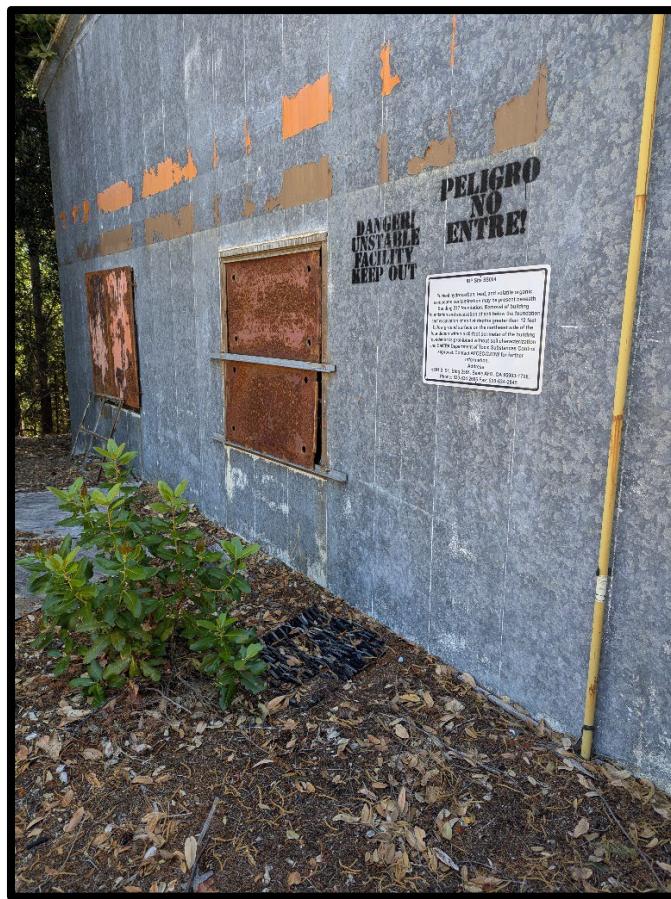
View of signage on northwest end of SS004, Building 217, former motor pool vehicle maintenance facility. No excavation of soil evident near building foundation. Building foundation intact and undisturbed.

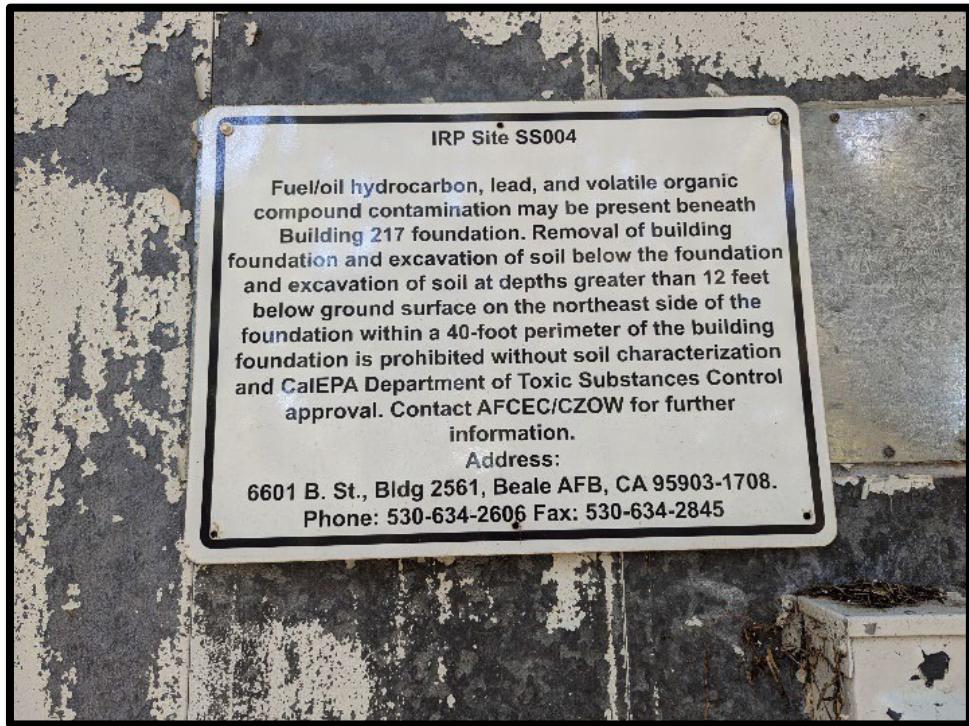
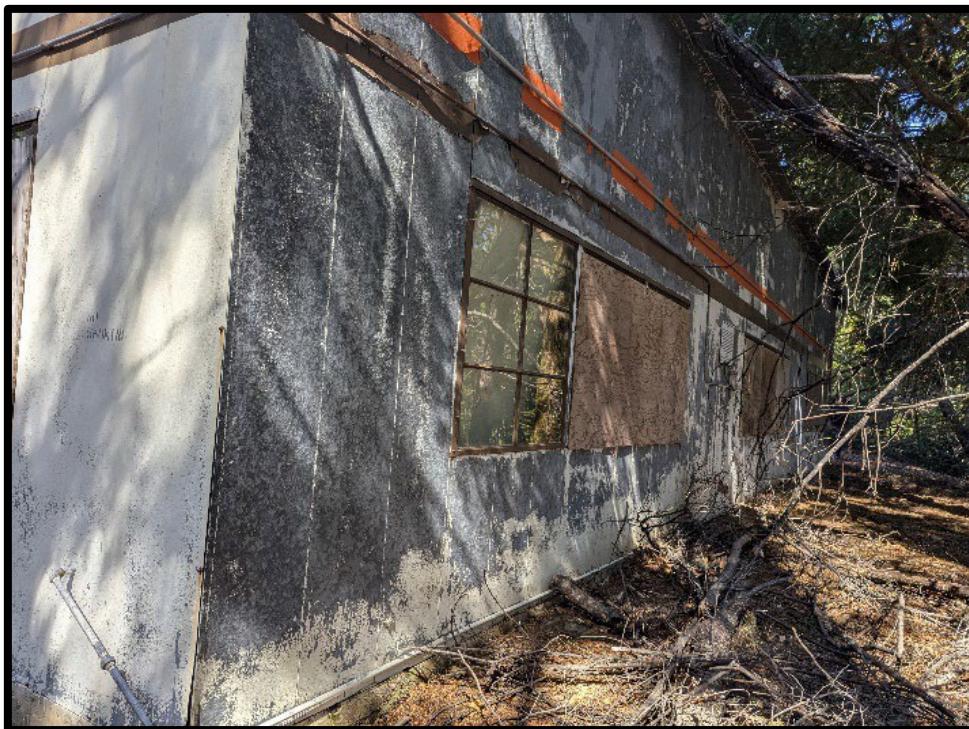
View of signage on northeast side of SS004, Building 217, former motor pool vehicle maintenance facility. No excavation of soil evident near building foundation where former discharge pipe was present. Building foundation intact and undisturbed. Minor sloughing, foundation edge, and animal burrow within the red boundaries as seen in photos.

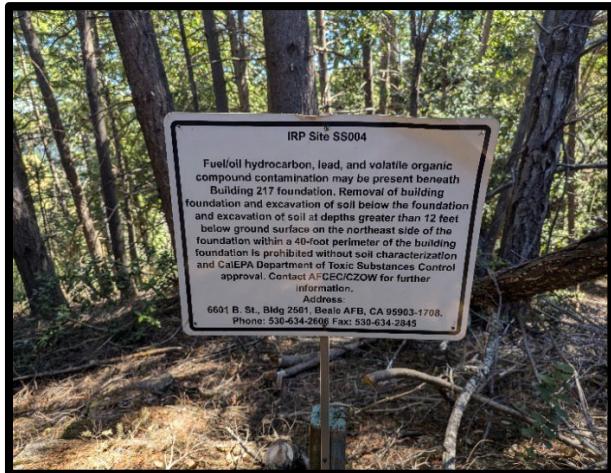
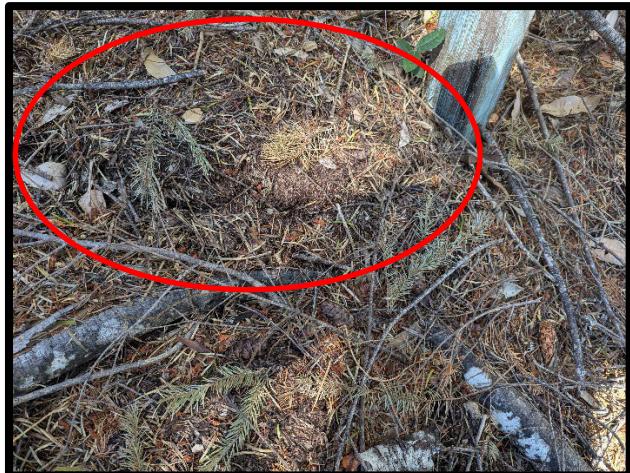
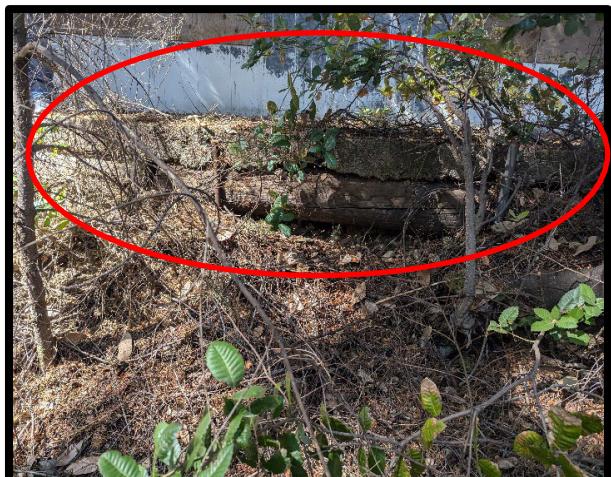
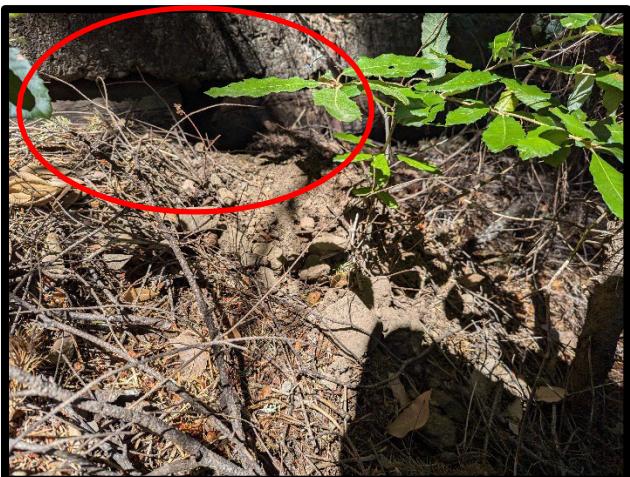
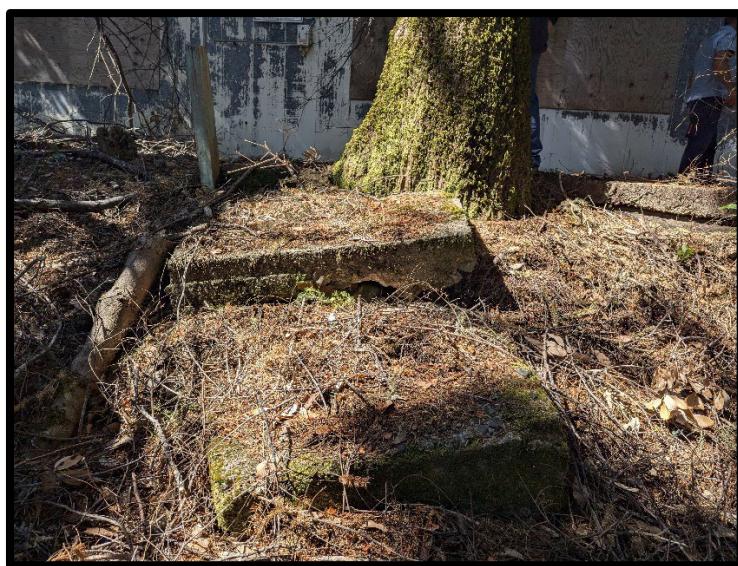
Minor sloughing was noted at the south outfall and recommend semi-annual inspections to ensure soils below 12 ft bgs are not exposed.

View of signage on northeast side of SS004, Building 217, former motor pool vehicle maintenance facility in the area directly opposite the east side of the building. No excavation of soil evident where former discharge pipe was present and excavation below 12 feet is prohibited. Building foundation is intact and undisturbed. Minor sloughing, foundation edge, and animal burrow within the red boundaries as seen in photos, as well as unstable concrete slabs at the top of the eastside slope.

The Decision Document requires continued annual site inspections to verify that the remedy is protective at Site SS004: Motor Pool. Semi-annual inspections are recommended to ensure additional sloughing at the south outfall can be identified and corrected before soils below 12 ft bgs are exposed to possible receptors.

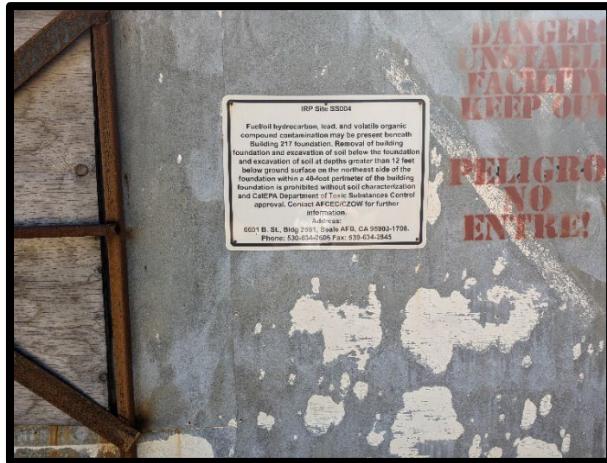
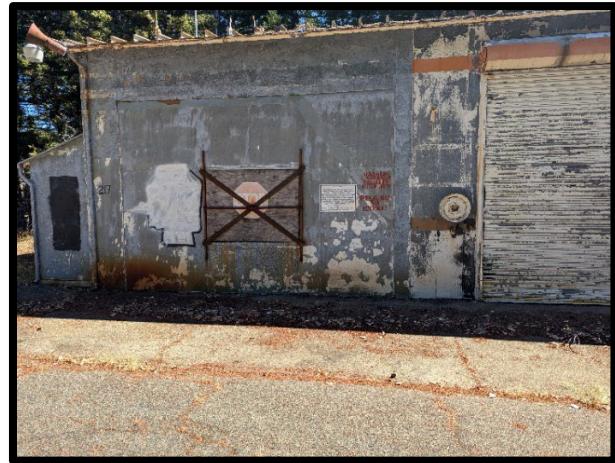
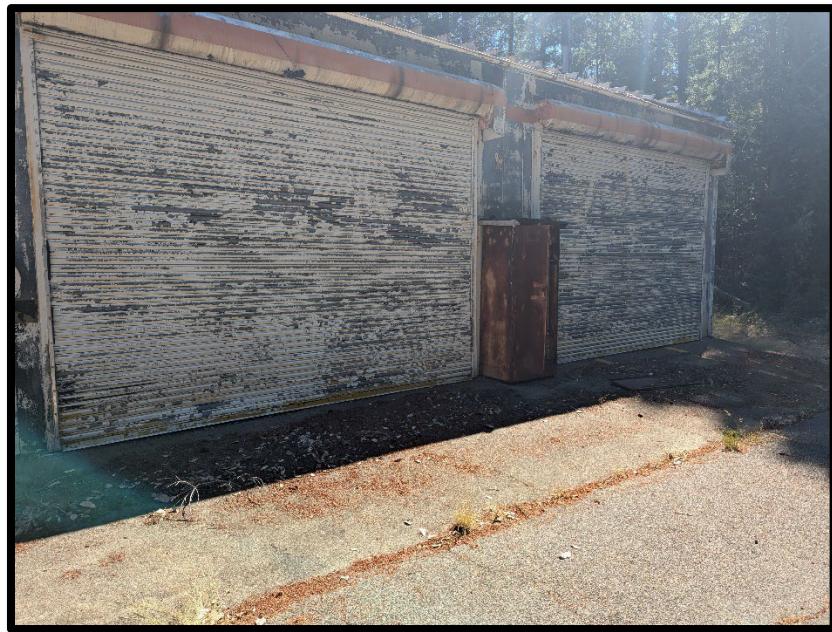
View of signage on southwest side of SS004, Building 217, former motor pool vehicle maintenance facility. No excavation of soil evident near building. Building foundation intact and undisturbed.
