SUBJECT: Final Point Arena AFS Second Five Year Review

**SECOND FIVE-YEAR REVIEW
FORMER POINT ARENA AIR FORCE STATION
POINT ARENA, CA**

SECOND FIVE-YEAR REVIEW REPORT
(AUGUST 2019 - AUGUST 2024)
FOR
FORMER POINT ARENA AIR FORCE
STATION, CALIFORNIA

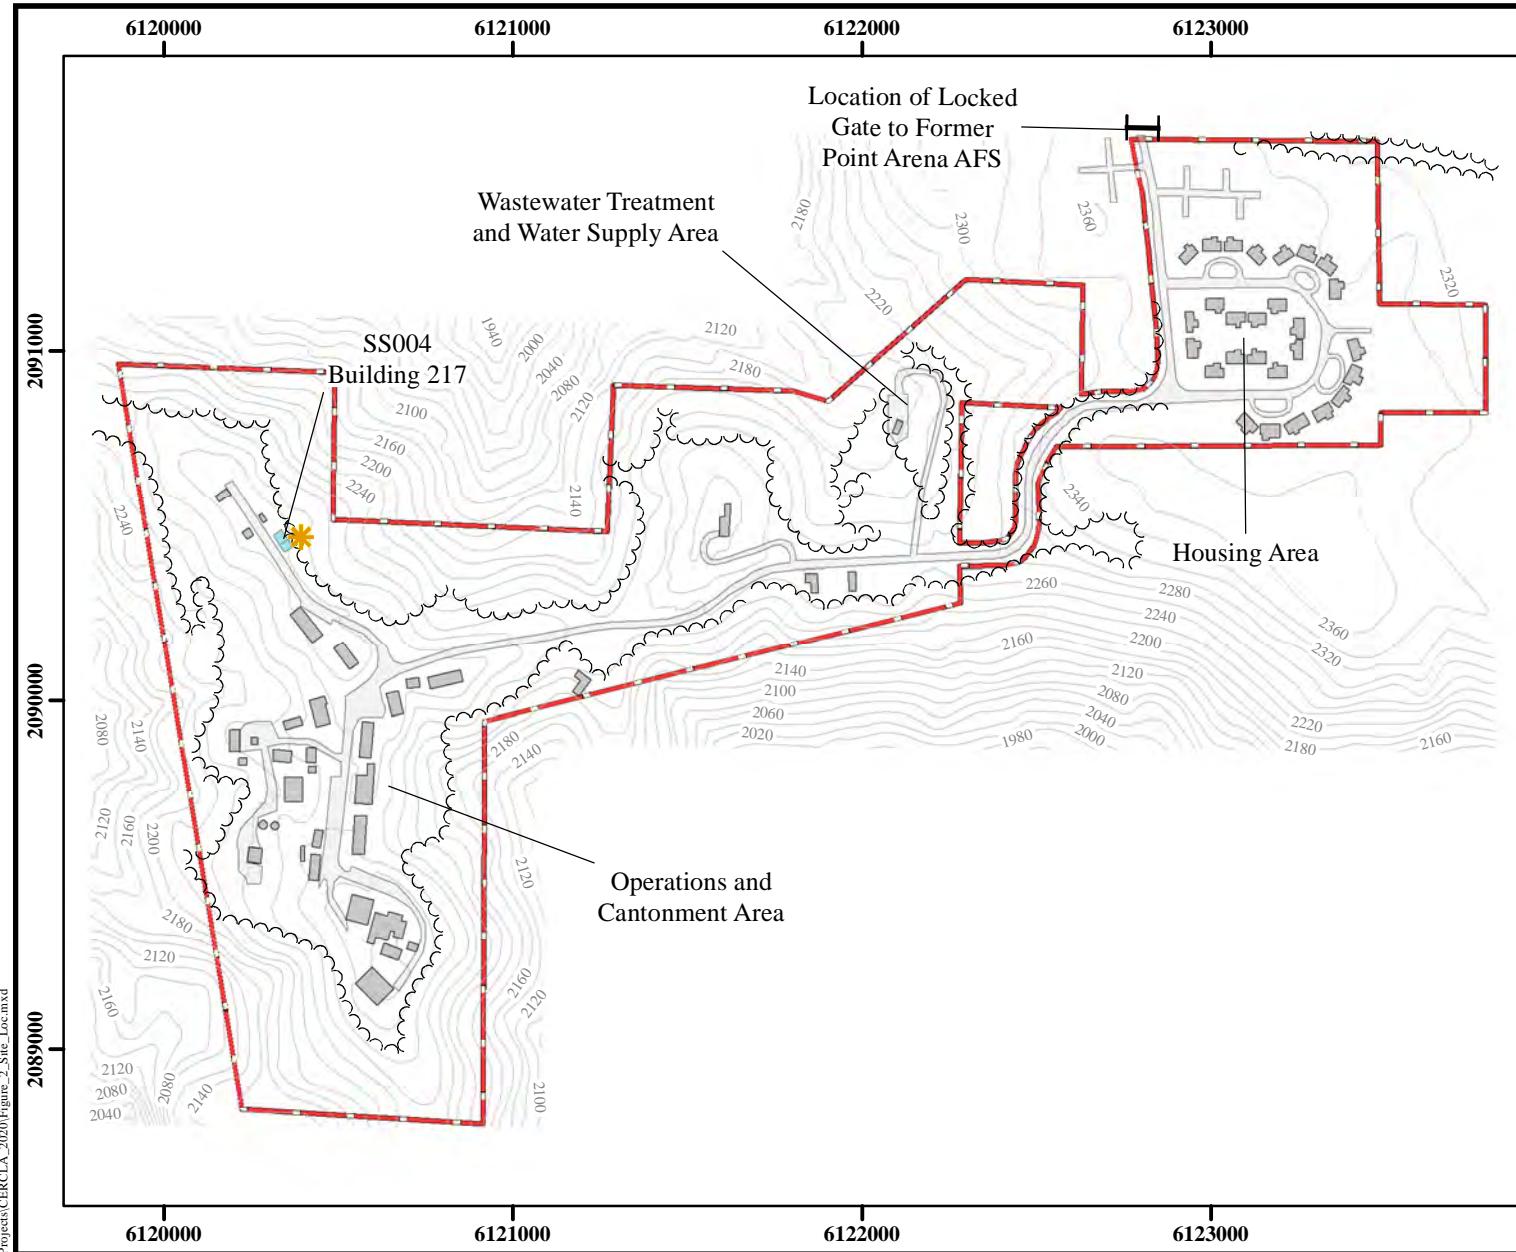
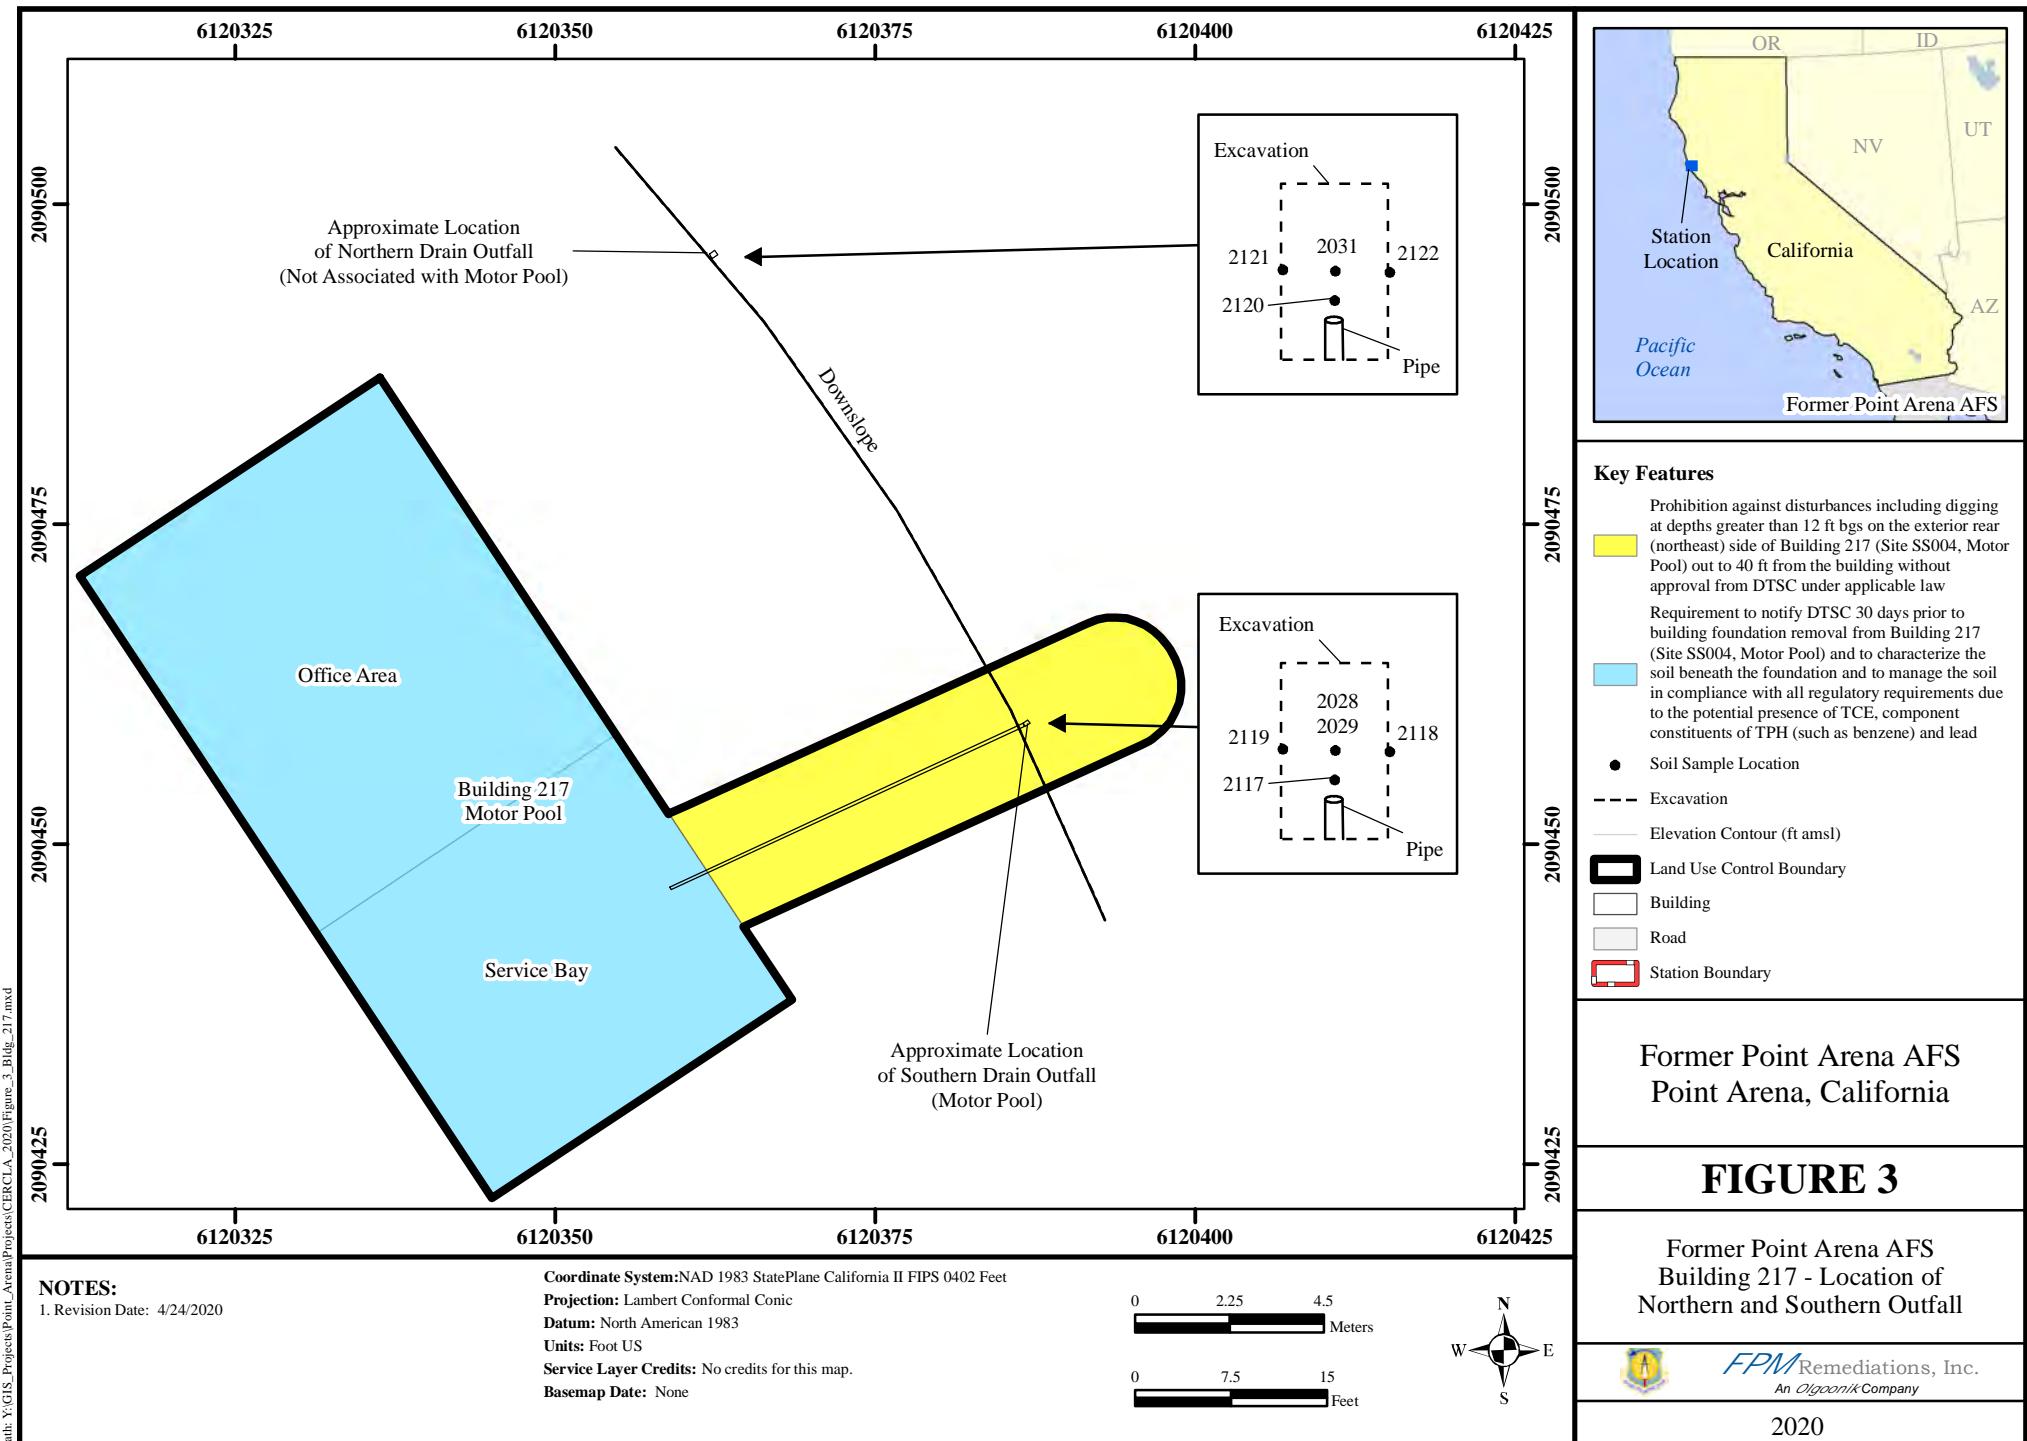
FIGURE 2

The Former Point Arena AFS Five-Year Review addresses the open CERCLA site, Site SS004: Motor Pool (Building 217). This site is illustrated in **Figure 2**. On this figure, the Land Use Control and the prohibition on soil disturbance at depths greater than 12 feet below ground surface are indicated in blue and orange, respectively.

The former Point Arena AFS is vacant with no tenants and the only access point has a locked gate (shown on **Figure 2**). There are no active Remedial Actions ongoing at the former AFS. All Remedial Actions were completed prior to 2015 DD. The nearest occupied property is 0.3 miles to the west-northwest from SS004 (Building 217). This property has no access road to the SS004 site and dense undergrowth in the forest makes access to the SS004 site difficult. The next nearest occupied property (residence outside the locked gate) is 0.6 miles from Site SS004 (Building 217). Given the maturity of the remedial program at the former AFS and lack of proximity to SS004, nearby residential property owners were not interviewed. The regulatory agency (DTSC) was not interviewed as they were an active participant in the Five-Year Review process by reviewing the work plan and accompanying the Air Force representative during the site inspection. There is occasional use of a portion of the former Air Force Station by the Mendocino County Sheriff Department and Placer County Sheriff Department for training purposes that averages 4 days per year. This training does not access the area surrounding site SS004 (Building 217) and therefore, does not access the soil underneath the building or the soil on the northeast side of the building. Based on the lack of access to the specific environmental issues at this site, it was deemed that interviews were not necessary with these users. There is one other usage of the site – the local
